## NEGATİF SU YALITIM (Bodrum-Asansör Kuyusu)

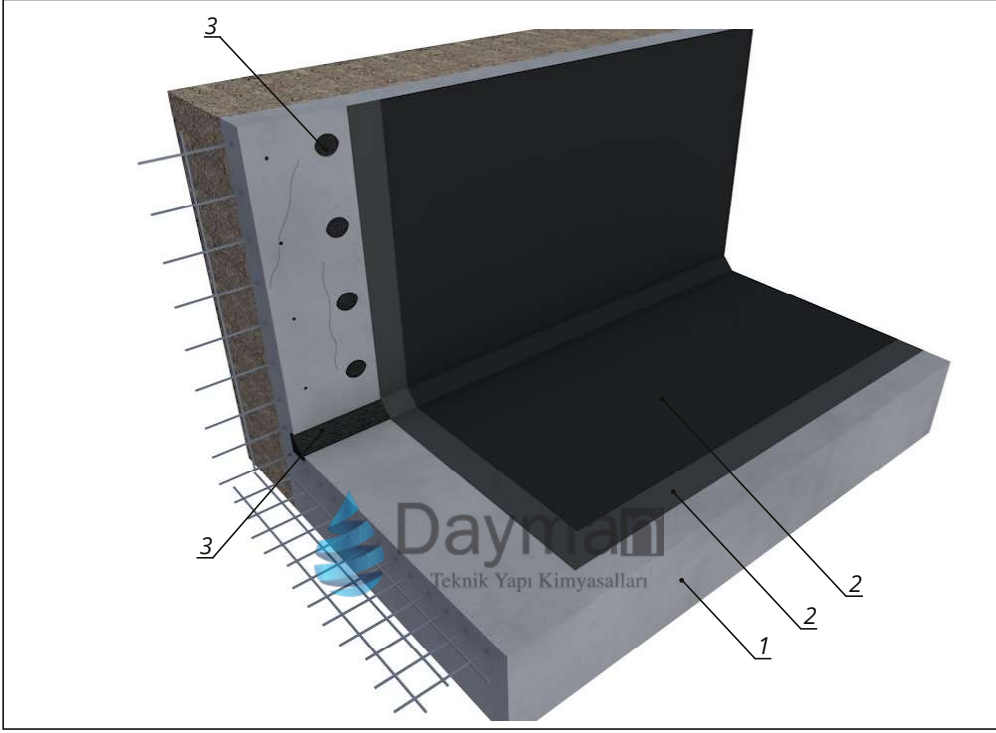
- 1- EĞİMLİ BETON
- 2 - CYRISTA 404 (Syf - 30)  
CYRISTA PLUS 2K 405 (Syf - 31)
- 3 - REPAIR PLUS
